Vessel Survey:
XXX Spencer 53

Prepared For:
XXX

Introduction

The vessel "XXX" was surveyed on XXX at XXX by Jim Merrick at the request of the buyer, XXX. The survey was conducted as a pre-purchase survey to assess the overall condition of the vessel and determine the present value of the vessel and its systems.

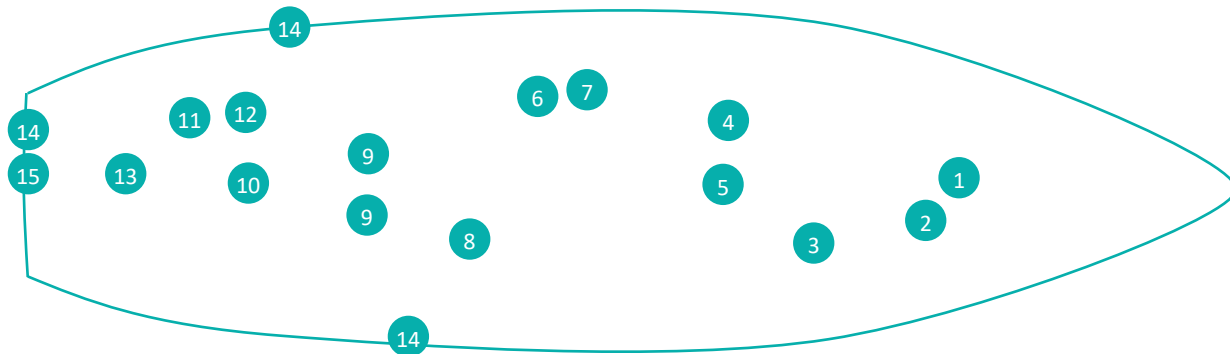
Number	Purpose	Condition
1	FWD head intake	Operational
2	FWD head discharge	Non-operational, seized closed
3	FWD sink discharge	Non-operational, seized open
4	Depth sounder	Not in use
5	Knotmeter paddlewheel	Operational (in keel)
6	Galley sink discharge	Non-operational, seized open
7	Sink sea water intake	Operational
8	Engine intake	Operational
9	Scuppers	Non-operational, seized open
10	Aft head intake	Operational
11	Aft head discharge	Non-operational, seized closed
12	Aft sink discharge	Non-operational, seized open
13	Rudder stock	Serviceable
14	Deck drains	Serviceable (above waterline)
15	Wet exhaust discharge	Serviceable (above waterline)

As noted above, a number of seacocks were non-operational. **REC A1**

- A1. Non-operating seacocks can become a safety issue at sea and should be corrected. The seacocks may be able to be freed with penetrating oil, otherwise they should be replaced.

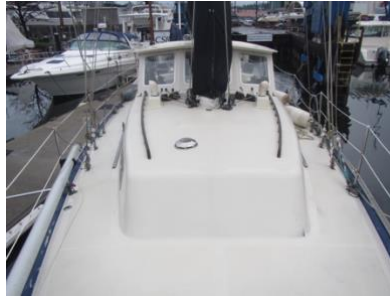
Forward House and Deck

A number of improperly filled holes were present in the deck and house. Gelcoat exhibits cracks and crazing at a number of locations as well as some pitting. [REC B10](#)

B10. Improperly filled holes in the deck can admit water into the cabin and core, potentially causing damage and weakening the deck. These holes should be excavated and filled with an epoxy filler.

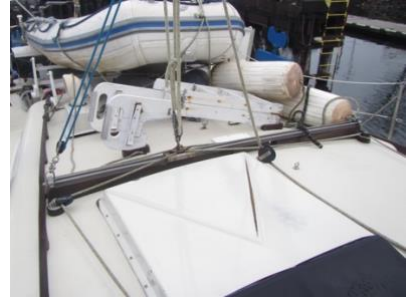
Aft House and Deck

A hard fiberglass dodger covers the main companionway and has rigid sides and windows. Two of the windows were cracked, but the dodger appeared structurally sound. The painted wood edge of the dodger roof exhibits some cracking paint along the joints. [REC B8](#)

- B7. The fields of small blisters should be monitored for growth or expansion. At a future haul out, these should be ground out and sealed.
- B8. The cracked windshield glass of the dodger should be replaced because it can break under pressure of a wave, potentially causing damage or injury. Where the joints in the dodger were exhibiting cracking, these should be repaired because the hand-holds in the roof could become weakened.

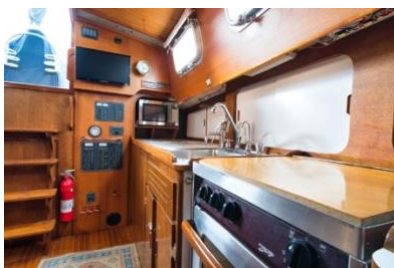
Galley

The vessel also includes a gimbaled Force10 three-burner stove and oven. Propane was controlled with a Xintex S-2A gas control and detection system, which was not operational, preventing the stove and oven from being tested. REC B14

B14. The propane control and detection system is an important safety feature of any vessel, and should be repaired, and the operation of the sensor and solenoid should be verified.

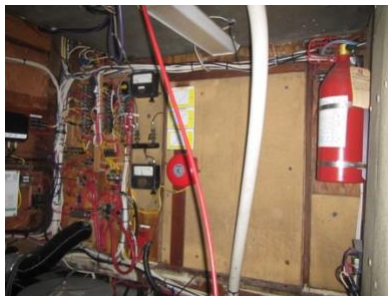
Engine Room Fwd

A leak was also noted in the water lift muffler, possibly introducing both water and combustion gases into the cabin. REC A4

The exhaust hose changes to a larger diameter hose along the aft wall of the engine room with an improper hose-to hose-connection that could leak both water and combustion gases into the cabin. REC A5

- A4. A leak in the water lift muffler was allowing water and exhaust gases to leak into the engine room. This should be addressed for safety.
- A5. A connection has been made between two different diameter hoses by simply inserting one hose into the other and clamping them. This is not a secure connection and can allow water and exhaust gases to enter the cabin. One section or the other of hose should be replaced with the same diameter and a connecting nipple should be used.

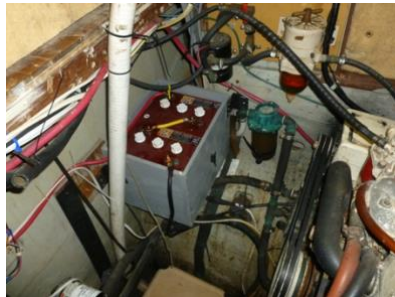
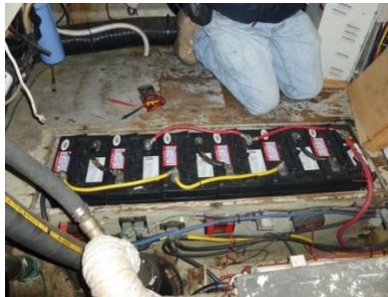
All batteries exhibited low electrolyte levels. REC B30

- B19. Low electrolyte in the batteries can lead to power battery performance and early failure. The cells should be topped up with distilled water or electrolyte solution and monitored for full charging.

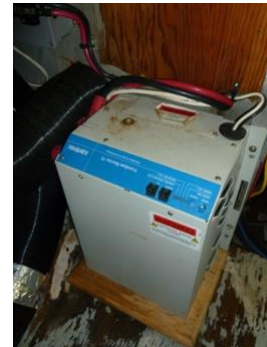
Charger/Inverter

Charging was provided by the engine alternator via a Balmar Max Charge MC-614 voltage regulator, a Xantrex Freedom 15 charger/Inverter, and 130w of solar panels located on the stern pulpit. Both alternator and shore power charging were operational, as were the solar panels. The inverter function of the Xantrex was tested and found not to be operational. REC B20

- B20. The Xantrex charger appeared to be operational for charging from shore power, but the inverter function was not operational. If AC inversion is desired, consider repairing or replacing the inverter.

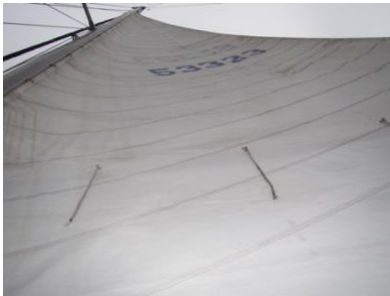
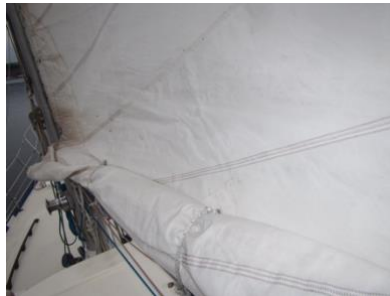
Main

The vessel was equipped with Dacron main, 140% genoa, staysail, and spinnaker. The main and genoa were inspected and found to be in poor condition and are significantly worn and sun damaged.

The main sail has a 24" tear along the first seam at the foot. [REC B30](#)

B30. A tear in the foot of the main sail of approximately 24" inches should be repaired if the sail is to be used.

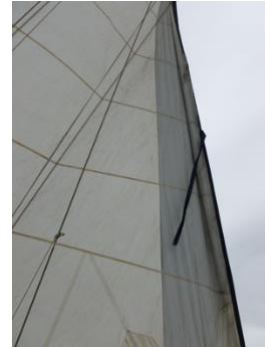
Genoa

The furling sail cover sewn to the genoa was significantly deteriorating at the foot.
