Vessel Survey: **1982 Lyman Morse Seguin 44**

The vessel "XXX" was surveyed on XXX at XXX and XXX by Jim Merrick at the request of XXX. The survey was conducted as a Pre-Purchase survey to assess the overall condition of the vessel and determine the present value of the vessel and its systems.

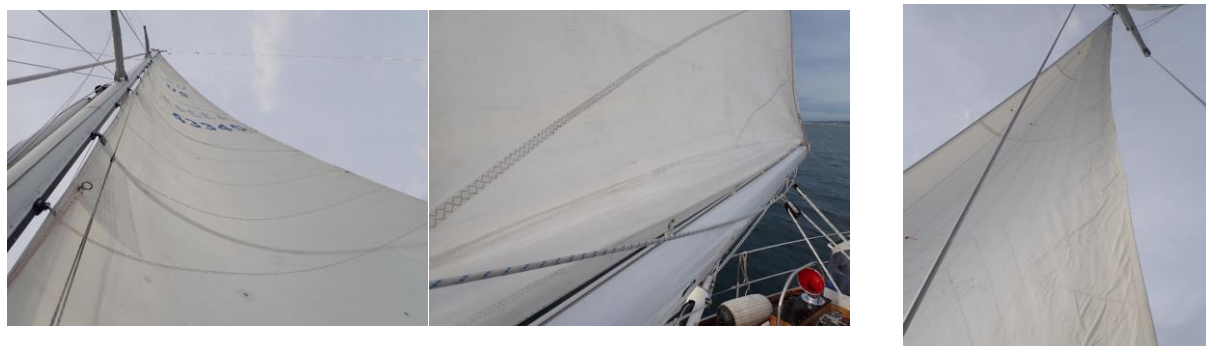
Some chafing was noted near the clews on the leach of the main. **FINDING: B25.**

- B25.** The main was showing some wear and chaffing on the leach near the clew and reef points.

Investigate further and repair or replace as needed.

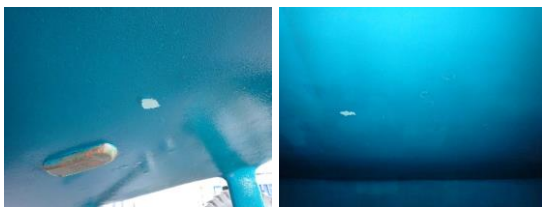
A small number of quarter-sized blisters in the antifouling paint were observed on the hull. **FINDING: B5.**

- B5. Blisters in antifouling paint is common, often caused by inadequate preparation or dry time during bottom service. Such blisters are largely cosmetic and not a cause for concern, but marine growth may attach aggressively to the exposed epoxy barrier coat.

Repair at the next bottom service.

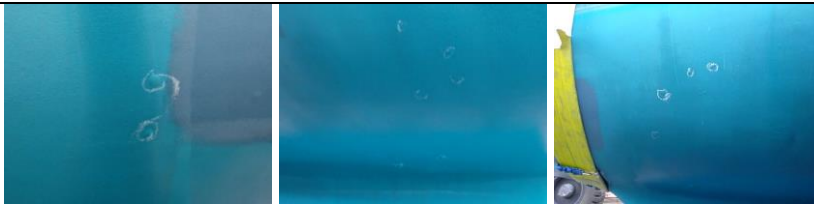
A number of quarter-sized laminate blisters were observed on the hull. **FINDING: B6.**

- B6. Osmotic blisters in the gelcoat and/or laminate are generally not structural in nature, but if they become large or dense enough, they can weaken the laminate.

We recommend monitoring the blisters and repairing as needed.

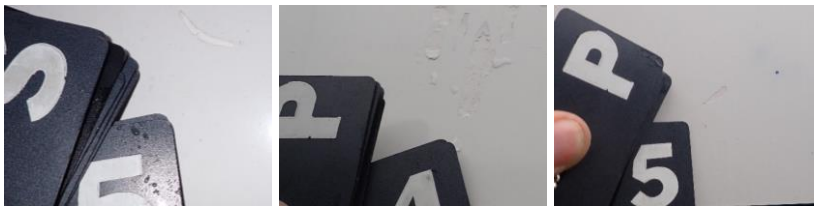
The scupper drains were plastic through hulls and the fairing and/or paint around them was deteriorating. **FINDING: B8.**

- B8.** The fairing and or paint around the plastic scupper fittings was deteriorating.

These are above the static waterline but would be submerged underway. Investigate further and repair as needed.

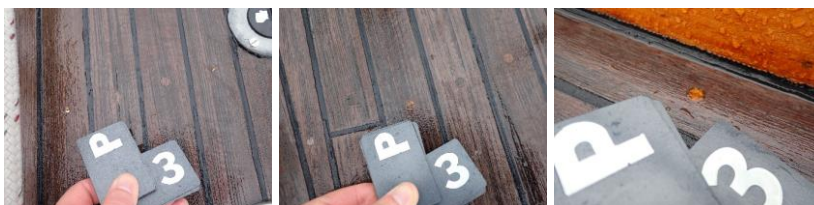
The teak decking was in serviceable condition with a few exposed fasteners or missing bungs. **FINDING: B9.**

- B9.** The decks retained much of their material but (as always) there are a few exposed fasteners, as well as missing or damaged bungs. Some bungs had been sealed with sealant rather than a bung—many of these were failing. There were no areas of open seams or failing caulking.

Exposed fasteners and missing, or improper bungs pose a risk of leaking. Replace the bungs, counter sinking the fasteners deeper if needed.

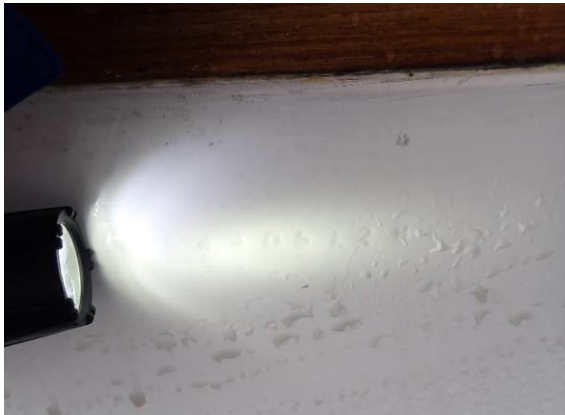
- A4.** The Hull Identification Number (HIN) was missing or illegible. All vessels are required to have a valid, readable HIN on or near the starboard stern quarter.

Repair or affix a new HIN placard to the vessel.
