Vessel Survey: **2000 Grand Banks Europa 43'**

Prepared For:
XXX

The vessel "XXX" was surveyed on XXX at XXX and XXX by Jim Merrick and Delaney Couvrette-Merrick at the request of XXX. The survey was conducted as a Pre-Purchase survey to assess the overall condition of the vessel and determine the present value of the vessel and its systems.

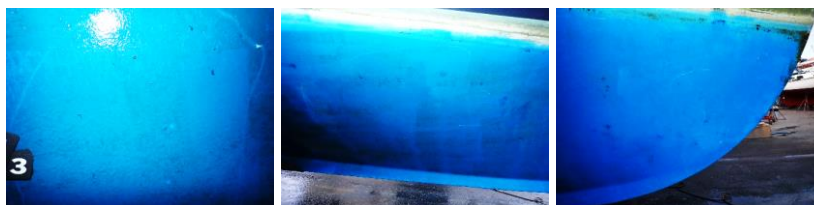
A small number of ½" sized laminate blisters were observed in localized areas on the hull. **FINDING: B1.**

B1. Areas of small blisters were noted in various areas on the hull, primarily along the starboard bow to midships. Osmotic blisters in the gelcoat and/or laminate are generally not structural in nature, but if they become large or dense enough, they can weaken the laminate.

We recommend monitoring the blisters and repairing as needed.

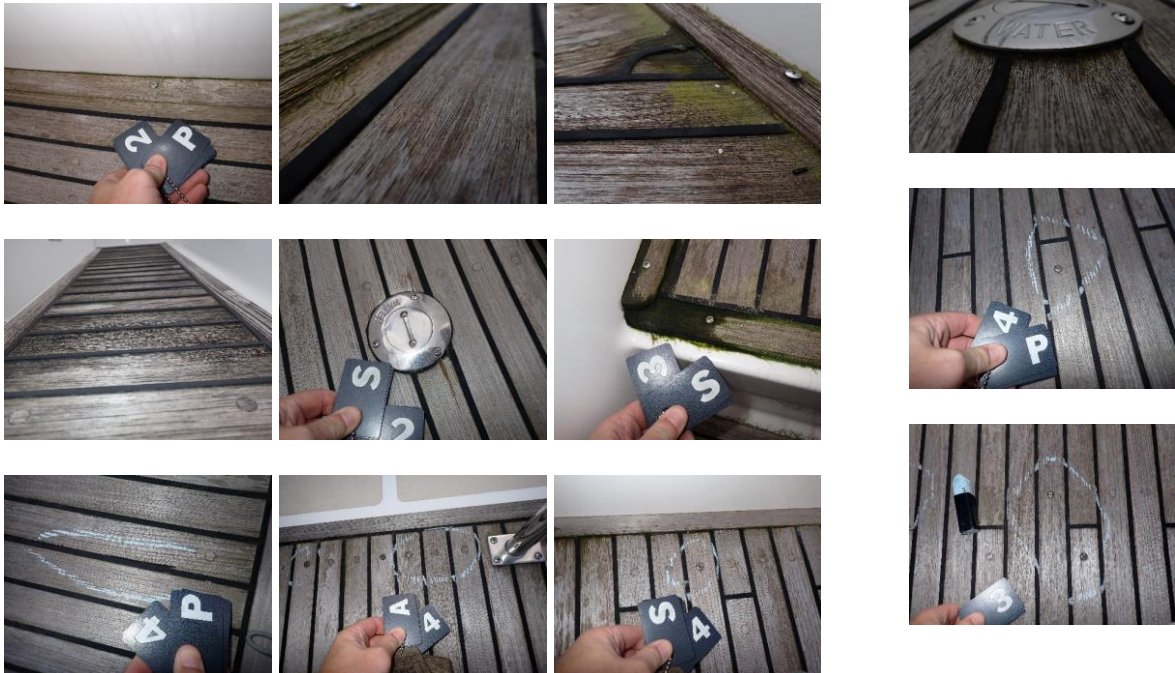
The decks are covered with fastened teak decking was in serviceable condition, however there were a few areas that require attention. **FINDING: B3.**

- B3.** The decks are in generally good condition and have much of their original thickness. However, a number of fasteners are exposed, some bungs have been lost or damaged. There are also areas of open seams and failing caulking.

The decks are at risk of leaking unless steps are taken to repair the missing bungs, failing caulking, and open seams.

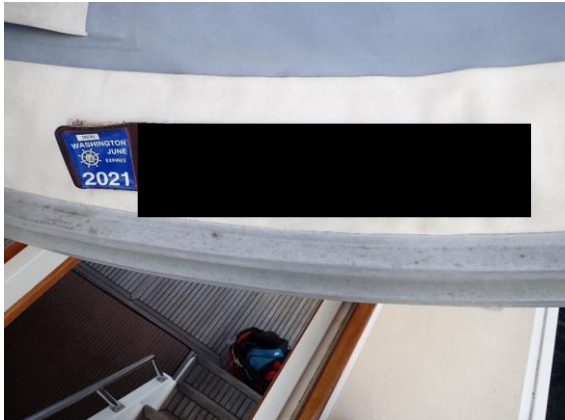
Tender State Decal and Numbers

A12. The State registration decal on the tender was out of date or missing.
