Vessel Survey:
XXX Spencer 53

Prepared For:
XXX

Introduction

The vessel "XXX" was surveyed on XXX at XXX by Jim Merrick at the request of the buyer, XXX. The survey was conducted as a pre-purchase survey to assess the overall condition of the vessel and determine the present value of the vessel and its systems.

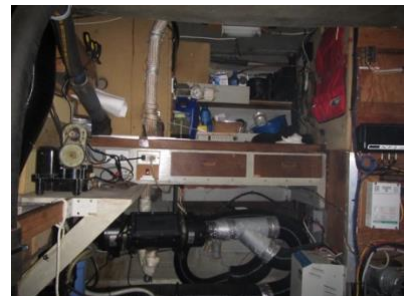
Engine Room Port

A leak was noted on the raw water pump on the engine. REC B15

B15. A leak in at the belt-driven raw water pump was evident during operation. The pump and hoses should be checked, and impeller replaced.
