Vessel Survey: **1982 Lyman Morse Seguin 44**

The vessel "XXX" was surveyed on XXX at XXX and XXX by Jim Merrick at the request of XXX. The survey was conducted as a Pre-Purchase survey to assess the overall condition of the vessel and determine the present value of the vessel and its systems.

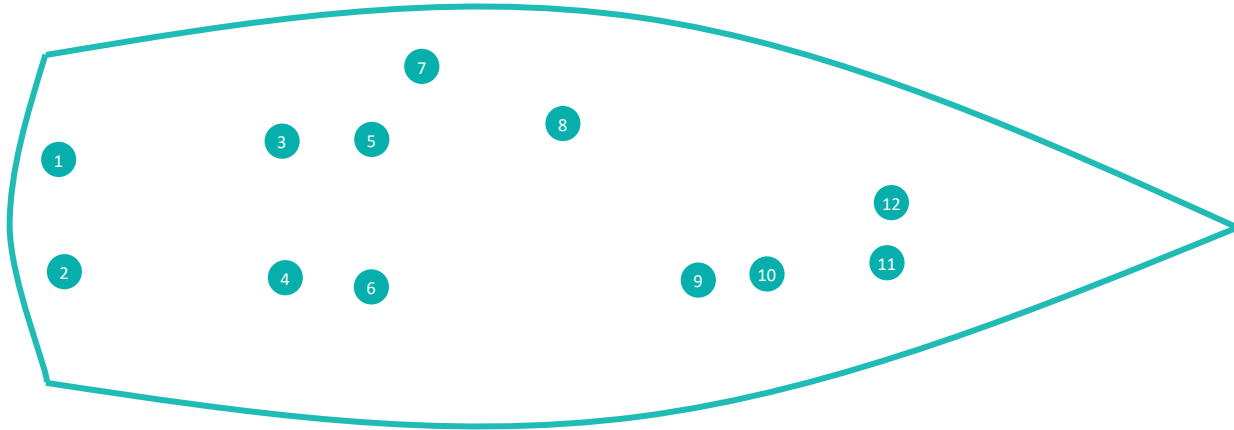
Number	Purpose	Type	Condition
1	Scupper drain	Plastic	Non-valved (above waterline)
2	Scupper drain	Plastic	Non-valved (above waterline)
3	Fridge heat exchanger	Bronze	Non-valved
4	Freeze heat exchanger	Bronze	Non-valved
5	Galley sink intake	Bronze ball	Operational
6	Watermaker intake	Bronze ball	Operational
7	Galley sink drain	Bronze ball	Operational
8	Head discharge	Bronze ball	Operational
9	MSD discharge	Bronze ball	Operational
10	Head intake	Bronze ball	Operational
11	Depth transducer	Plastic	Non-valved
12	Speed transducer	Plastic	Non-valved
